THE WALL PAINTINGS IN THE CHURCH OF ST CANTIANUS IN VRZDENEC, SLOVENIA

PAST CONSERVATION-RESTORATION INTERVENTIONS, CONSERVATION CHALLENGES, INTERPRETATION AND EVALUATION

ANITA KLANČAR KAVČIČ

Institute for the Protection of Cultural Heritage of Slovenia, Restoration Centre,
Ljubljana, Slovenia, anita.kavcic@rescen.si

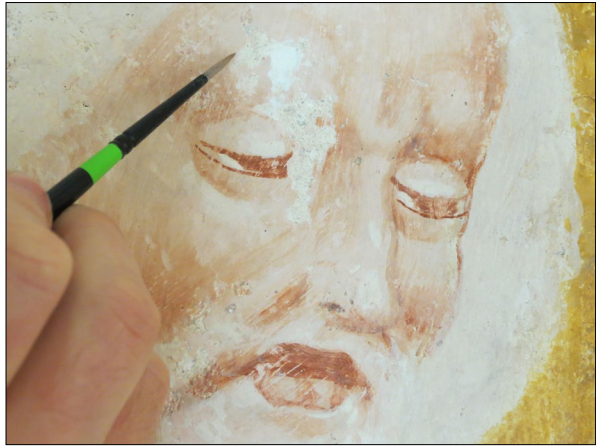
1. Retouching St Joseph's face from the Birth of Christ on the northern wall of the chancel, the work of Master Leonard from the beginning of the 16th century (© Institute for the Protection of Cultural Heritage of Slovenia, Restoration Centre, Ljubljana (IPCHS, RC), photo: Anita Klančar Kavčič, 2017)

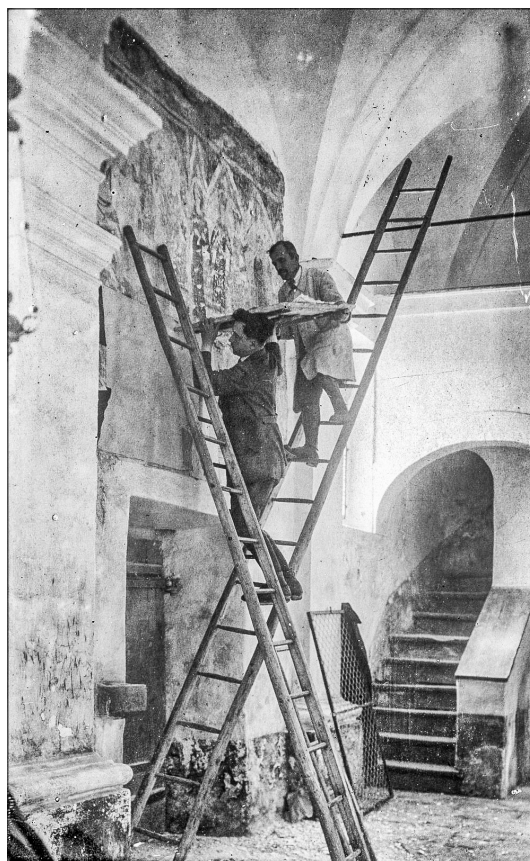
5. Matej Sternen and France Stele during the detachment of the younger layer in the nave in 1925 (© Ministry of Culture of the Republic of Slovenia, Heritage Information and Documentation Centre, Ljubljana (INDOC Centre), photolibrary)

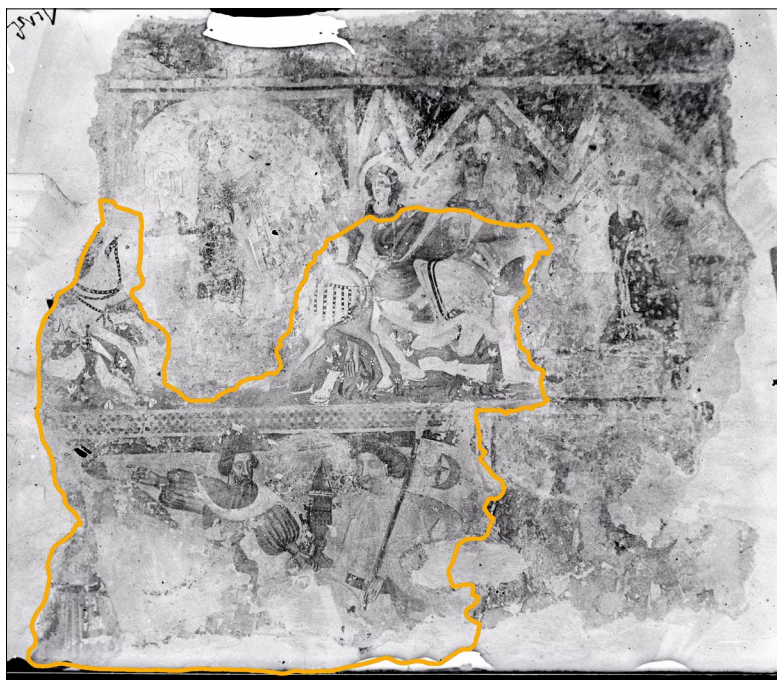
6. The younger and detached layer is marked orange, the rest is an older painting
(© INDOC Centre, photolibrary)

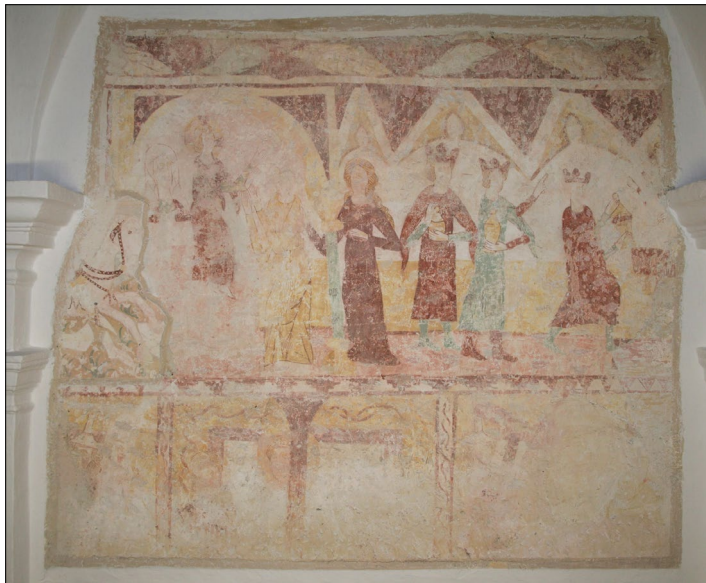
8. The present state of the wall painting on the southern wall after Sternens's intervention in 1925. Sternens puttied damaged area using mortar and then retouched missing parts of the paint layer (© IPCHS, RC, photo: Tine Benedik, 2013)

All Sternens interventions were compatible with the painting since he had used inorganic materials, such as lime, sand and pigments. In areas of lesser damage, he retouched using reversible and removeable tempera, while using fresco technique on freshly applied plaster in areas of greater damage.

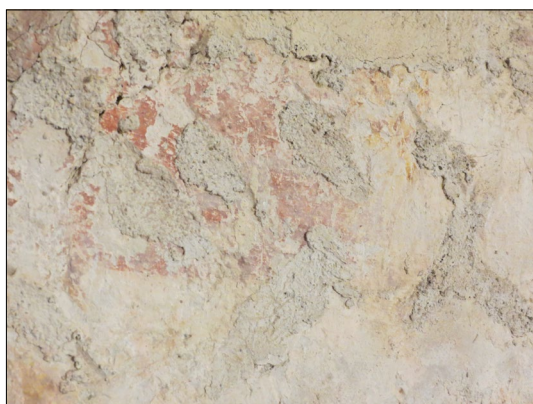
9.–10. Sternen filled losses in the plaster with lime mortar, taking no particular care to seal off the edges of the fillings, and so the rough surface of the fillings differs from the original surrounding plaster. He left some fillings uncoloured (left), while overpainting others (© IPCHS, RC, photos: Anita Klančar Kavčič, 2017)

After the detachment of the younger layer, Matej Sternen restored the older one, which remained in the church. He treated the damaged parts of the plaster by filling them in with lime mortar, taking no particular care to seal off the edges of the fillings, so the rough surface of the fillings differs from the original surrounding plaster. If we examine his work, we cannot help but feel that it was done quickly and with a kind of ‘impressionistic’ painting approach. Quick brushstrokes and quick, somewhat superficial plaster applications are visible. His interventions do not enhance the paintings, he merely preserved the appearance of a damaged painting as a result. He left some fillings uncoloured, while overpainting others. He did the smaller ones in *tempera a secco* and the larger ones *in fresco* on freshly applied plaster. As early as 1925 he used the so-called *tratteggio* retouch but in very simplified way so the viewer could discern the difference between the original and the additions. Conservator France Stele wrote that ‘the missing areas in the paintings were retouched using the technique of hatching to not insult the viewer, and yet are still clearly discernible to the expert as an addition.’²⁰ The first use of so called *tratteggio* technique is mentioned also by Stele in 1965,²¹ where he writes that Cesare Brandi started using that technique only after the Second World War.²²

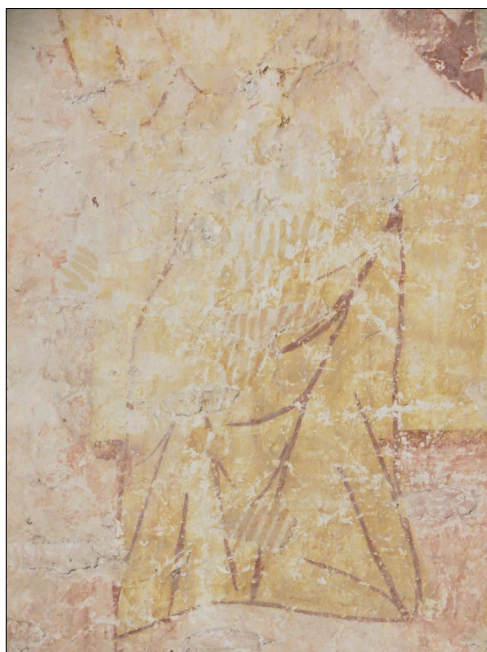
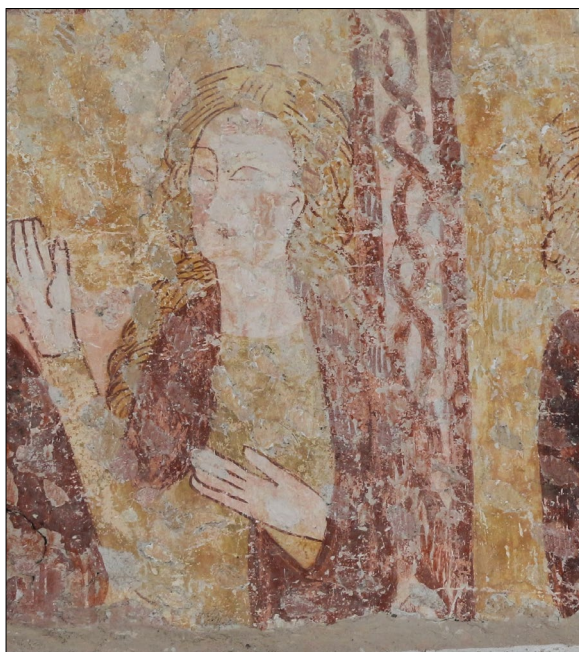
11.–12. As early as 1925 Sternén used the hatching retouching technique, so the viewer could see the difference between the original and the additions (Photos: Vid Klančar, 2021, 2017)

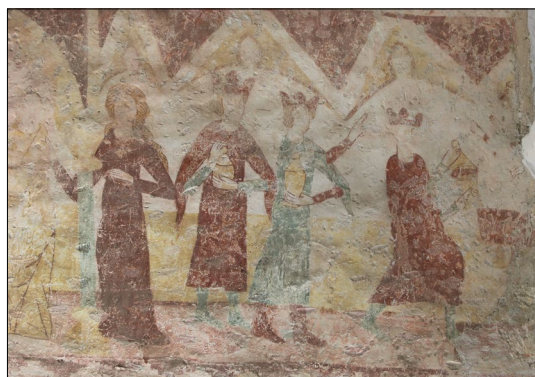
13. The present state of the wall paintings after Sternén's interventions, southern wall of the nave (Photo: Vid Klančar, 2022)

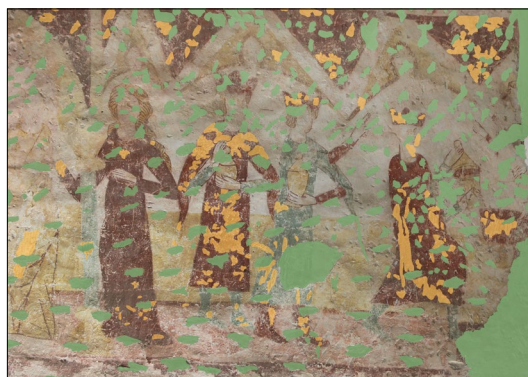
14. Wall painting with digital highlighting of Sternén's interventions. Green marks the puttyed areas, which were later retouched, orange marks the areas with Sternén's inpainting on the original plaster, on areas of the abraded paint layer (Photo and graphic editing: Vid Klančar and Anita Klančar Kavčič, 2022)

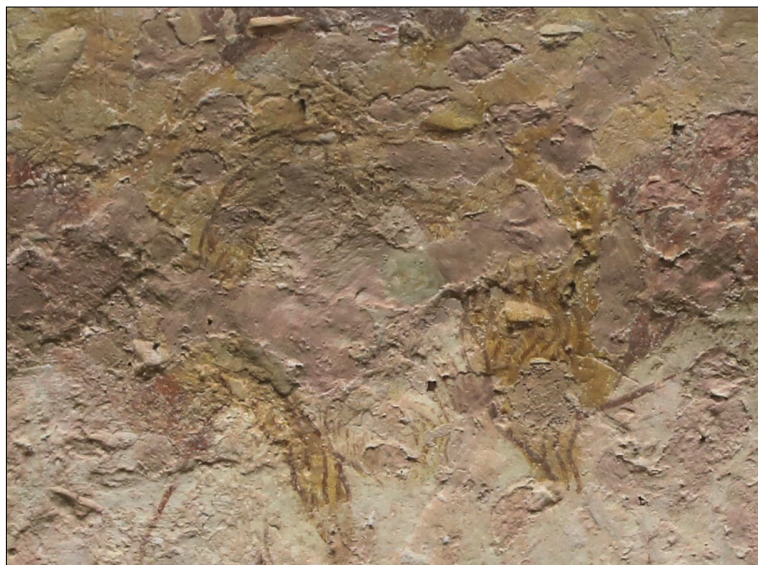
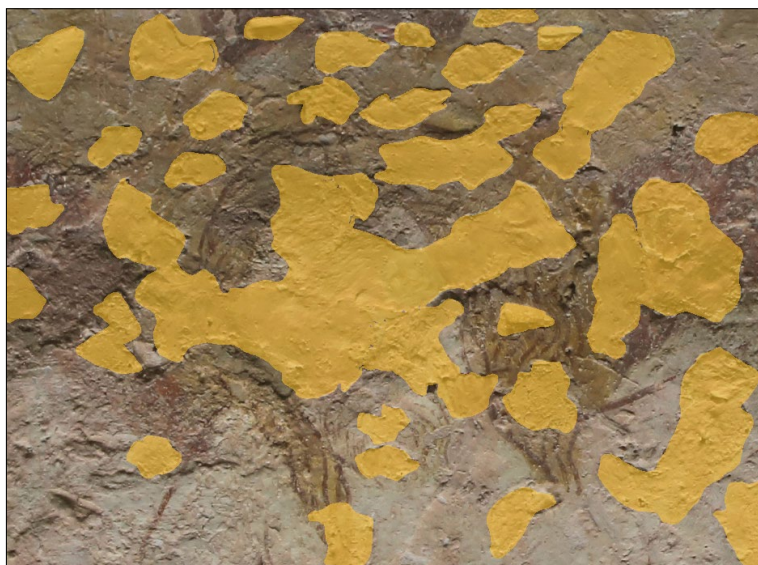
15.–16. Photographs taken in raking light and with Sternens interventions marked to illustrate how little of Christ's face is in fact preserved. A large part of painting was puttied and then repainted
(Photos and graphic editing: Vid Klančar and Anita Klančar Kavčič, 2022)

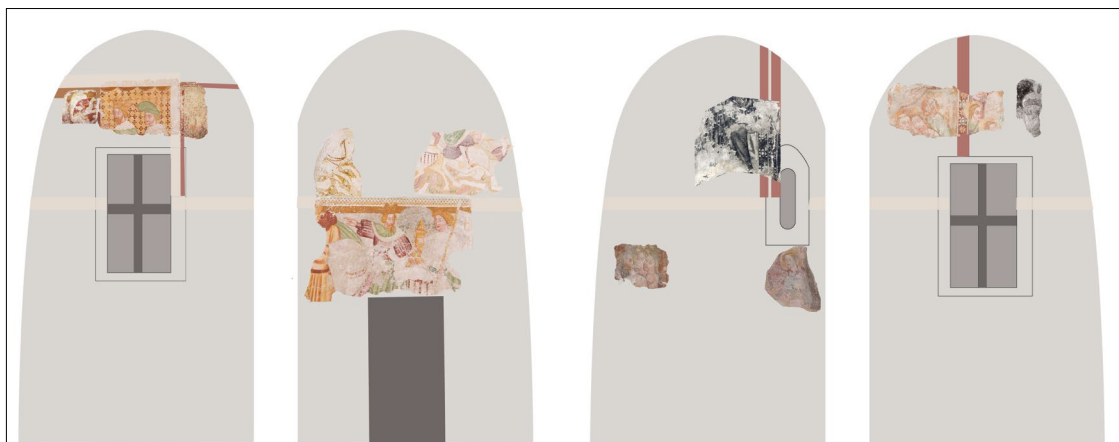
17. A digital reconstruction of the detached fragments of the younger layer (Digital scheme: Anja Urbanc, 2008)

Nine fragments of the younger painting were detached in 1925, leaving only two in the church. The detached fragments ended up at various locations and institutions in the next decades. To explain the situation, we use the restorer Anja Urbanc's digital schematic reconstruction.²³

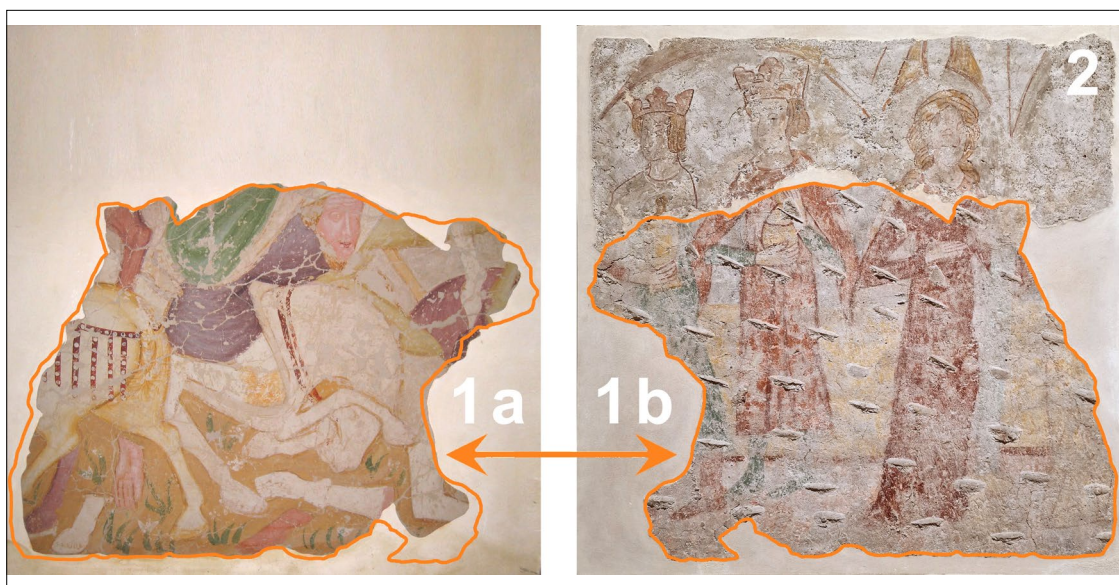
18. When Sternen detached a fragment of the younger layer (1a), a paint layer of the older painting (1b) imprinted on its back. In 1958 restorer Emil Pohl successfully separated both layers. The upper part with heads (2) is a complete reconstruction by Sternen. Moreover, the detached fresco, now in the National Gallery, is presented in mirror image (Photos and colour scheme: Vid Klančar, 2022)

1958: Restoration of the detached younger fresco with a negative print of the older one. A restorer separated the negative from the younger painting (Emil Pohl, IPCHS).⁸

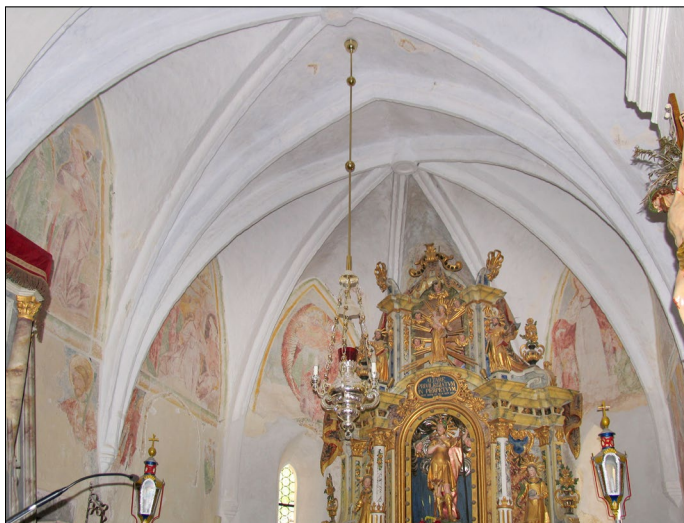
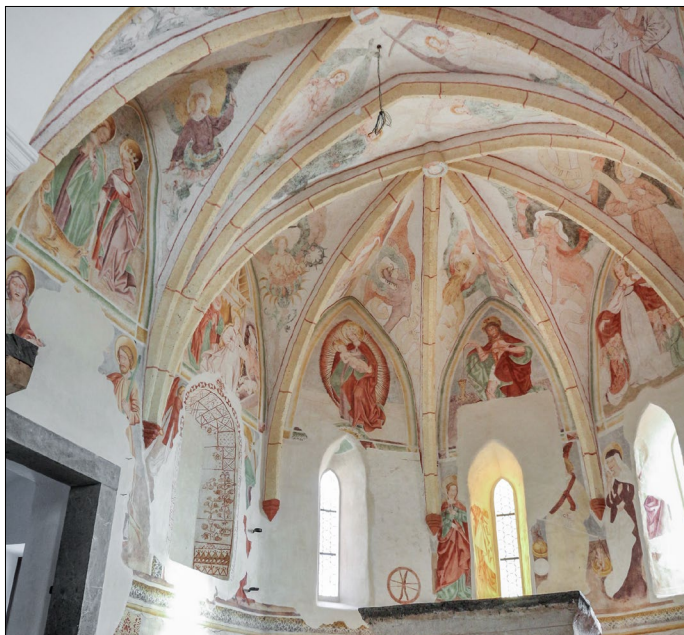
19.–20. Photo of the chancel in 2006 shows that Sternen (in 1925/26) uncovered only the paintings on the walls. The paintings on the ceiling were uncovered and restored between 2006 and 2017 (© IPCHS, RC, photos: Anita Klančar Kavčič)

Between 2006 and 2017 a final uncovering and restoration of the wall paintings in the chancel was undertaken.²⁶ In 2006, first the ceiling paintings of the chancel were uncovered and restored, then we began intervening on the wall paintings, encountering the problem of preserving and presenting the past interventions. During our work, we came across a painted built-in niche from 1632 that we decided to restore and present. We have also preserved, restored and presented the original (decoratively painted) plasters from the time when the chancel was built. During the restoration, we faced the problem of preserving Sternen's interventions from 1925/26. We removed some of his interventions for technical reasons: his paint layer was smudged and water-soluble and the plaster unstable, partly brittle and coming off. At the same time, some of the interventions were also aesthetically and art historically obtrusive because in parts they covered the original Gothic painting and substituted it with unsuitable inpainting. But in some cases, the Gothic painting under Sternen's inpaintings was so poorly preserved that the removal of the latter would cause the motif to be undecipherable. Which is why we compromised, keeping these inpaintings on the wall.

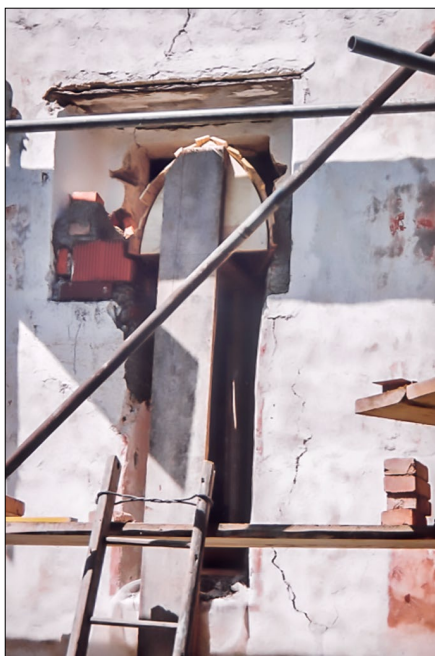
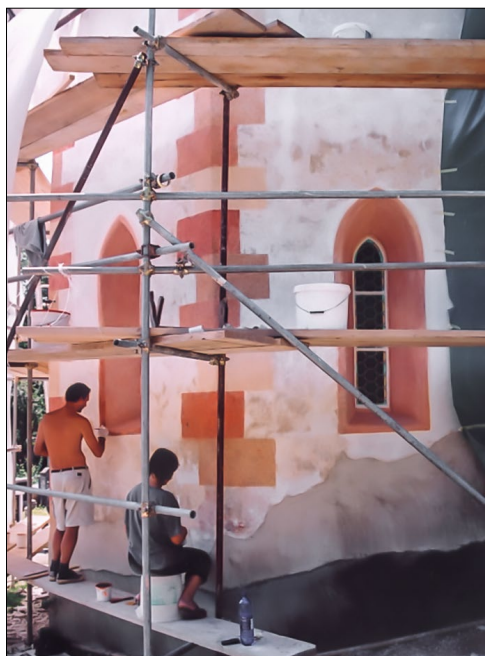
21.–22. In 2004, the reconstruction of the Gothic windows was carried out in the chancel. This intervention affected both the interior and exterior (Photos: Martina Lesar Kikelj)

In 2004, a major intervention was carried out in the chancel.²⁵ It affected both its interior and exterior. Gothic windows replaced the former Baroque windows which had been part of the chancel since the rebuilding of the church in the 18th century. A committee of experts also stipulated in 2004 that, based on the preserved Gothic openings, a reconstruction of Gothic windows should be carried out.

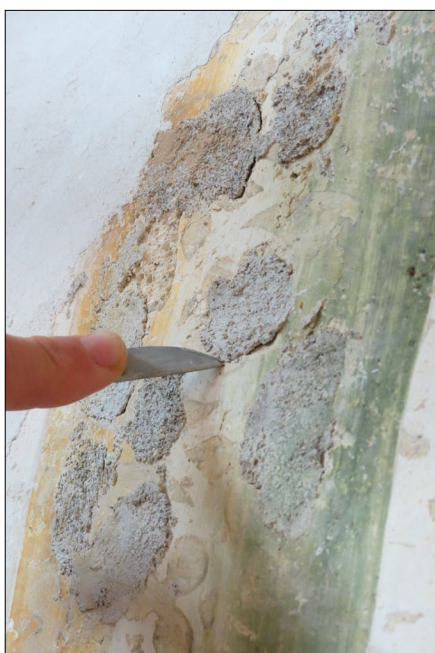
23.–24. Removing Stern's infillings and inpaintings which covered the Gothic painting. They were removed for technical and aesthetic reasons (© IPCHS, RC, photos: Anita Klančar Kavčič, 2014, 2006)

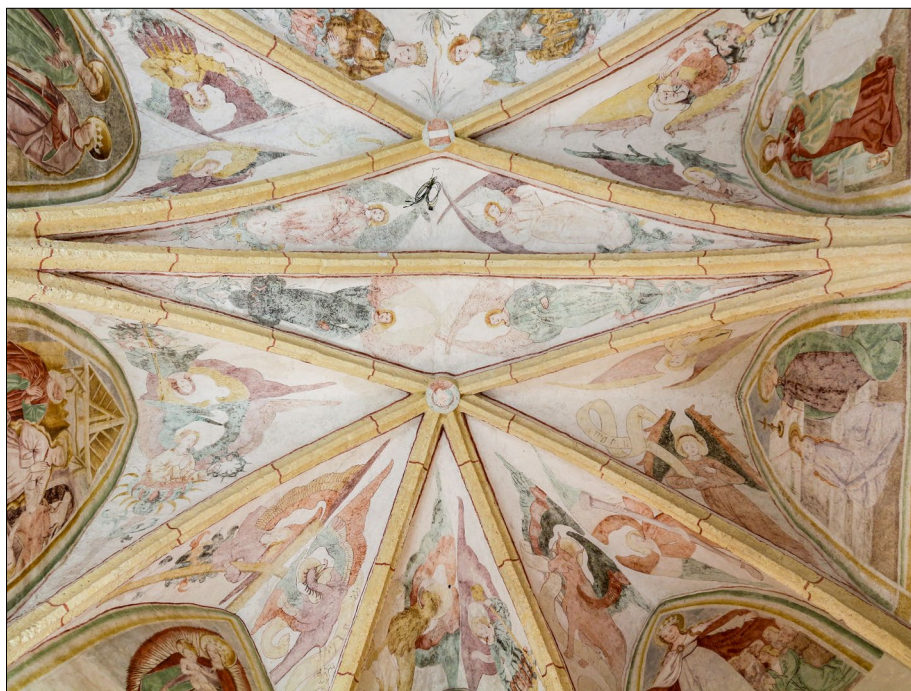
27. Ceiling of the chancel after the uncovering and restoration in 2017 (© IPCHS, RC, photo: Anita Klančar Kavčič)

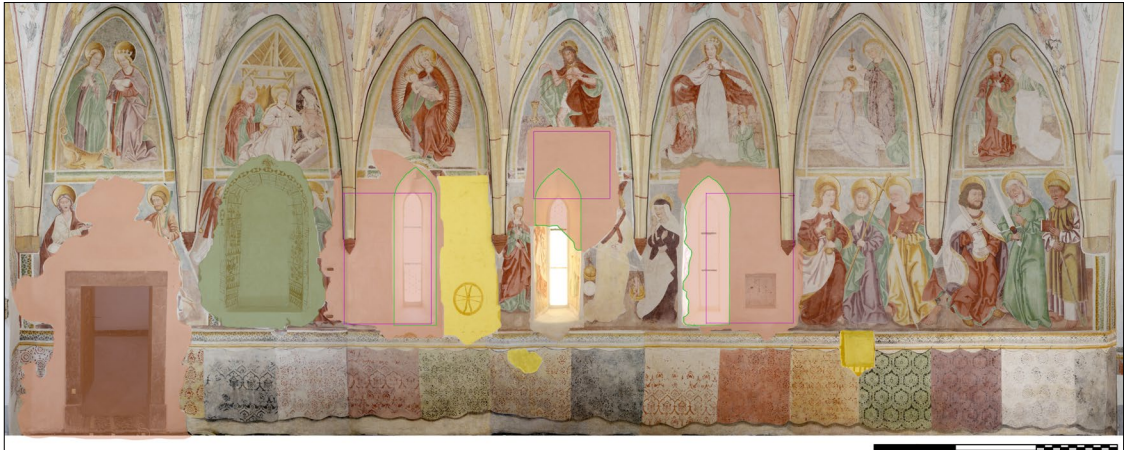
- The original plaster with the fragmented wall painting from the first half of the 15th century
- The painted niche of 1632
- The former Baroque windows
- The damage on Gothic wall paintings caused by installation of Baroque windows
- Reconstruction of the Gothic windows (2004)

28. Orthophoto of the wall paintings in the chancel after the last conservation-restoration treatment in 2017. Past historical interventions are marked in different colours (Photo and graphic editing: Vid Klančar, 2020)

After the interventions in the chancel, a photo brochure of the wall paintings was made (Fig. 28). It marks the historical alterations and reconstructions, and displays the current presentation of the chancel paintings.

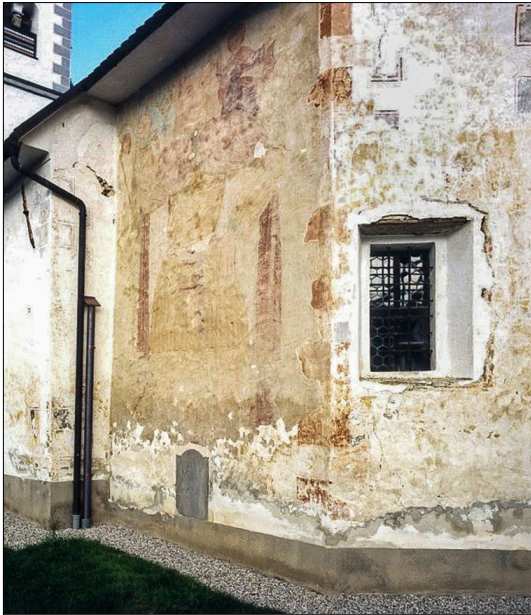
29. Exterior of the chancel with the original, poorly preserved painting of St Christopher and the Baroque window
(© IPCHS, RC, photo: Valentin Benedik, 2001)

The final, fourth section of this article concerns the paintings on the southern exterior walls of the church. The detachment of the monumental painting of St Christopher was a major procedure endorsed by an expert committee of art historians, conservators, restorers, and locals due to the poor condition of the painting. Based on archival photos and the remains of the painting, a copy in fresco technique was made in 2004. The original was conserved and returned to the newly built chapel of rest in Vrzdenc in three transferable pieces. The detachment of the painting, production of a copy, placement of the detached painting in the chapel of rest are all again major substantive, technical and aesthetic interventions. Changing the location also means changing the meaning and context. The monumental painting of St Christopher usually appeared on façades along the road so anyone passing by could see him – be it travellers, worshippers, the ill. It was also believed that any ill person who sees St Christopher, lives to see another day. But it is questionable whether there could be any other, better solution for this painting. In the worst-case scenario, the detached painting would end up in a depot.

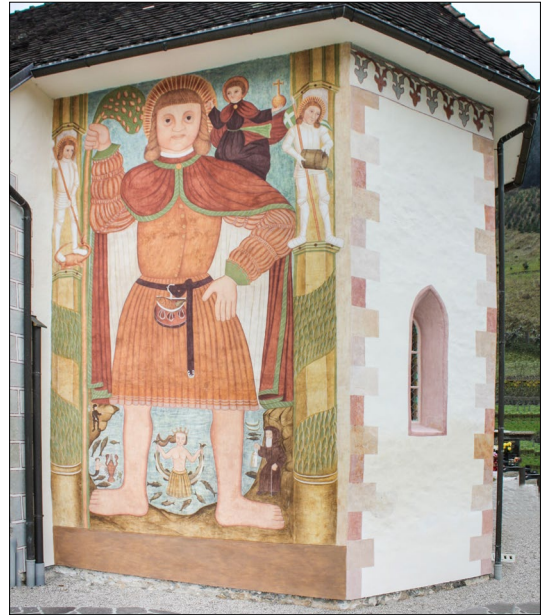
30. Exterior of the chancel after a copy was made of the monumental painting of St Christopher and after the reconstruction of the Gothic windows
(Photo: Vid Klančar, 2008)

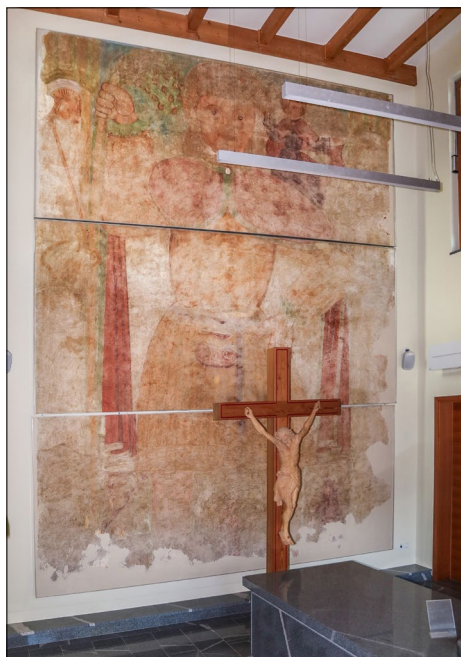
31. The detached and restored painting in the chapel of rest (Photo: Vid Klančar, 2022)

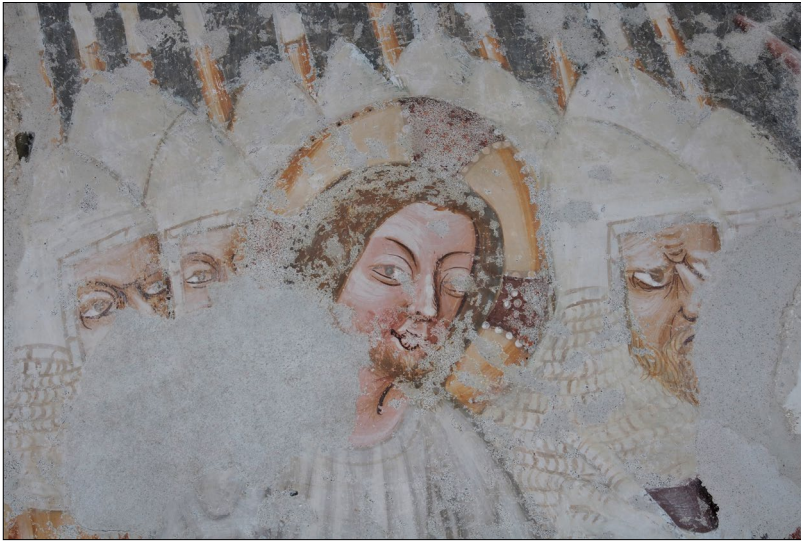
32. An example of retouching by tonal adjustment on the Gothic wall paintings in the church of St Judoc in Šentjošt. It is very minimal retouching, that pushes the damaged areas into the visual background (Photo: Vid Klančar, 2021)
