# MEDIEVAL MURALS IN NORWEGIAN STONE CHURCHES

SUSANNE KAUN

ELISABETH ANDERSEN

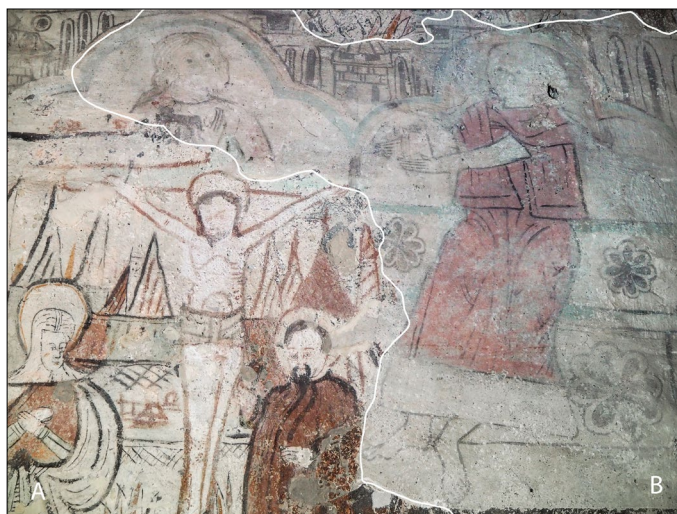
1. Dale Church in Luster.  
 Medieval wall paintings, (A) covered by  
 a 16<sup>th</sup> century mural, (B) partly exposed  
 (Photo: Susanne Kaun, 2016)

As an example, in the 1960s, three layers of murals were discovered in Dale Church (Sogn og Fjordane). The conservator decided to remove an 18<sup>th</sup>-century mural of biblical figures in painted niches to uncover an extensive figurative mural of biblical scenes dating from the 1560s.<sup>11</sup> The third layer, medieval murals, is still untouched and just partly uncovered (Fig. 1). In other churches,

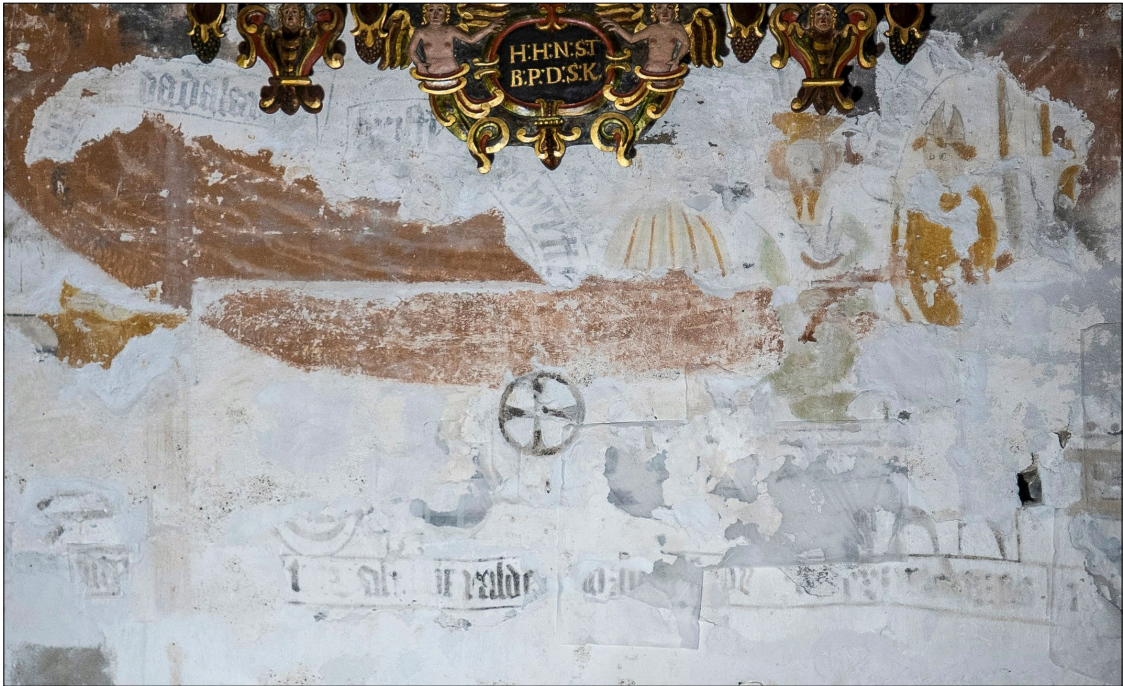
2. Tingvoll Church. Three layers with paintings side by side, partly uncovered, fragmentarily preserved and affected by decay: a consecration cross, a medieval figurative motive with inscriptions and a painted drapery from the 17<sup>th</sup> century (in red colour) (Photo: Susanne Kaun, 2021)

though, such as Tingvoll Church (Fig. 2), murals from different periods have been uncovered and are on view side by side, without any explanation or visual guidance to help understand the art historical contexts and periods to which they belong. This can be confusing and give a misleading impression of the murals.

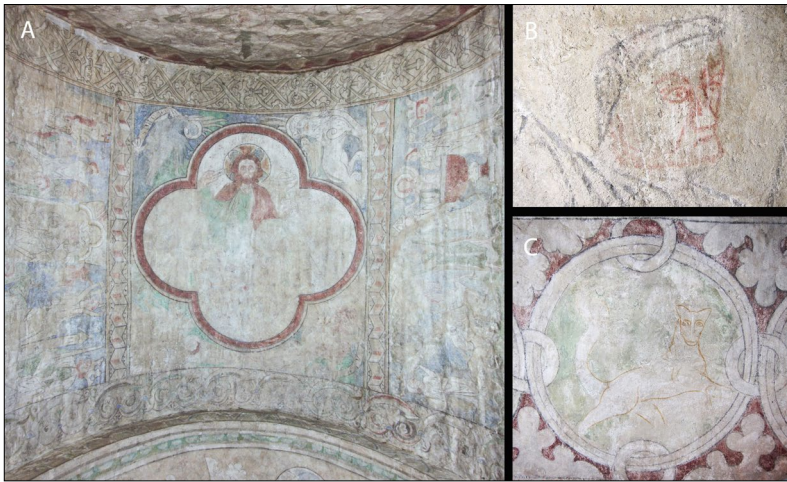
4. Nes Church in Telemark. (A) Murals on the vault depicting Christ in Majesty surrounded by symbols of the four evangelists. The murals have been heavily restored, with repainted frames, (B) figurative additions and (C) repainted contours (Photos: Susanne Kaun, 2014)

In Nes Church (Telemark), the recurring ornaments and borders that frame the figurative scenes were retouched by the conservator. The restoration of the figurative motifs has been carried

out in a more restrained manner; nonetheless, figure contours have been freshened or repainted (Fig. 4). Most likely, the murals were fragmentary when they were uncovered and could not be easily read. Other examples of conservators making generous additions to poorly preserved murals, probably with the aim of making them more legible, can be found in other churches, as well.

In the ceiling there is a *Majestas Domini*, Christ in Majesty, surrounded by symbols of the evangelists (Fig. 4). The lives of the church's patron saints, St Peter and St Paul, along with Simon Magus, are depicted on the north and south walls.<sup>29</sup> Red, blue, and green predominate in these colourful murals. The images are framed in frieze-like rows and were originally accompanied by a descriptive text underneath each scene; today, only a few text fragments are preserved. Medallions (imitating textile *refil*) and draperies decorate the lower parts of the walls.

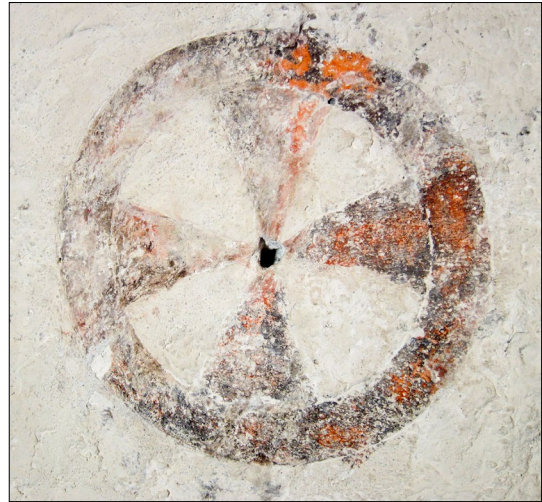
5. Tanum Church. A well-preserved consecration cross (Photo: Susanne Kaun, 2011)

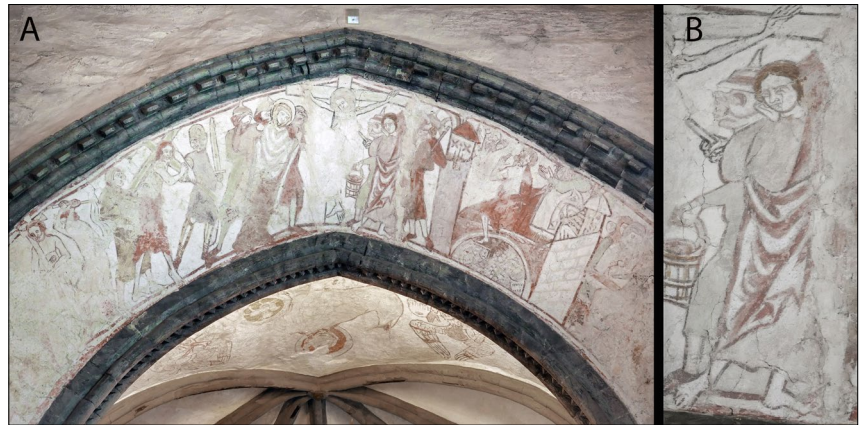
6. Alstadhaug Church.  
 (A) *The Passion of Christ above the chancel arch*, (B) *detail of St John the Evangelist*  
 (Photos: Susanne Kaun, 2017)

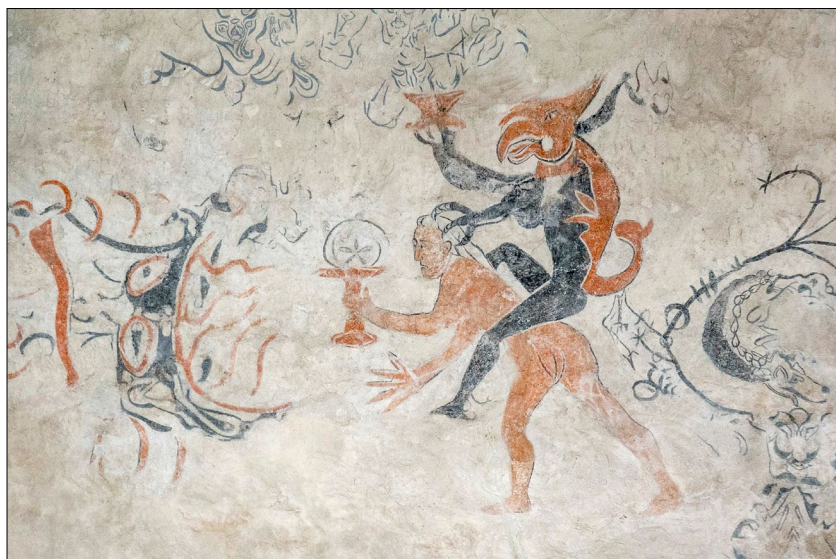
8. Botne Church. Devils on the north wall in the nave (Photo: Susanne Kaun, 2020)

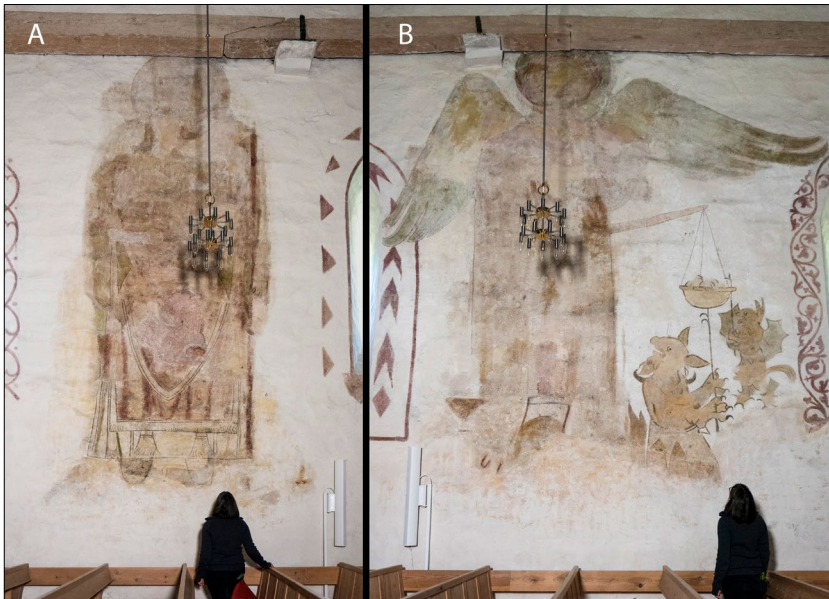
9. Kinsarvik Church. (A) A bishop on the south wall in the nave, (B) St Michael on the north wall, both around five metres tall (Photos: Elisabeth Andersen, 2020)

The largest figures portrayed in a Norwegian church are in Kinsarvik Church, which was built around 1200. On the north wall of the nave, there is a figure of the archangel Michael five metres in height weighing souls on scales, while two small devils, a fraction of Michael's size, attempt to pull the scales in their favour (Fig. 9B). Opposite this mural, on the south wall, stands an unknown bishop, who is as tall as the archangel (Fig. 9A). Both works have suffered decay and only the ground layers have been preserved. The contours and ornaments have been partly repainted.

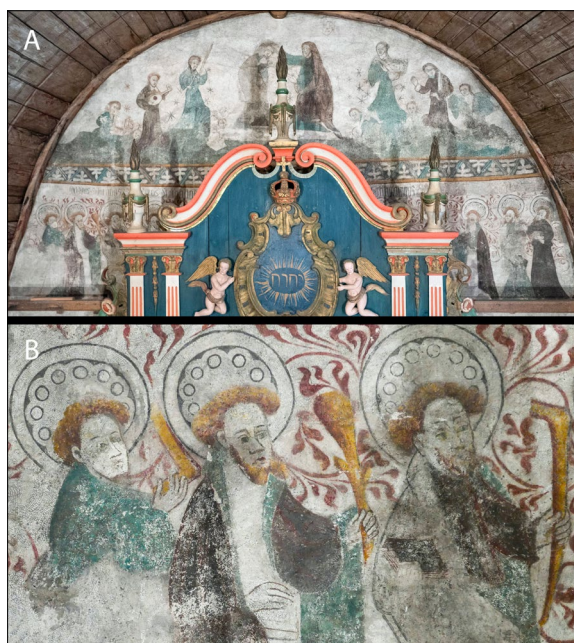
10. Slidre Church. (A) *The Coronation of the Virgin, flanked by angels playing instruments. Underneath, the Assumption of Mary (or the Ascension of Christ) – covered by the altarpiece – flanked by the Twelve Apostles; (B) detail of three apostles (Photos: Susanne Kaun, 2022)*

Dæhlin argues that there are affinities between this mural and those painted by the Union Master in Fogdö Church and Strängnäs Cathedral in Sweden.<sup>41</sup> However, the murals in Slidre Church resemble

Although nothing indicates that the same workshop was active in different churches, a connection to a Swedish workshop is strongly suggested for the murals in Slidre Church. It could be that the poor condition of many of the works has obliterated details that could be used to identify similar styles and techniques.

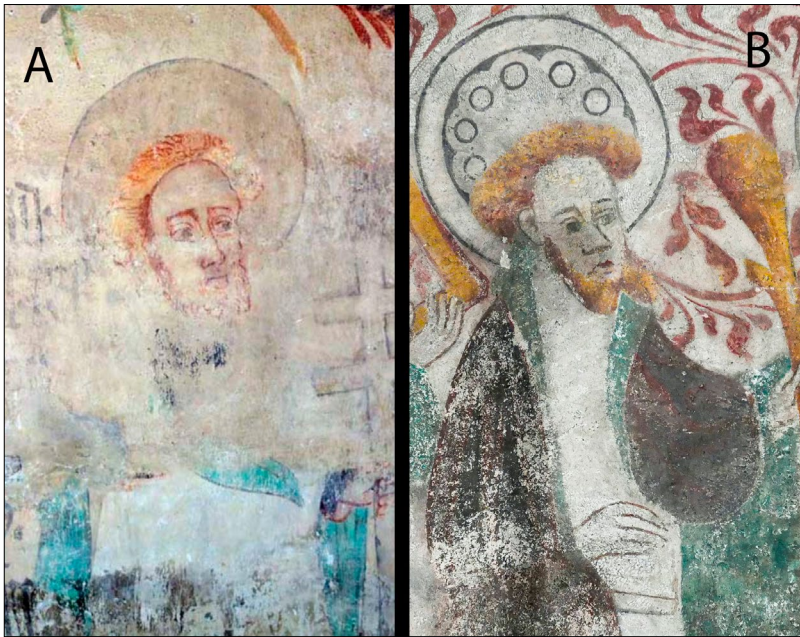
11. (A) Tensta Church, Sweden. Detail of an apostle (Photo: Lars Johnson). (B) Slidre Church. Detail of an apostle (Photo: Susanne Kaun, 2022)

and he may also have worked in Danmarks Church outside Uppsala. It is unknown if he travelled to Slidre, but the similarities between the paintings are so striking that it is tempting to believe that he or one of his pupils created them (Fig. 11).

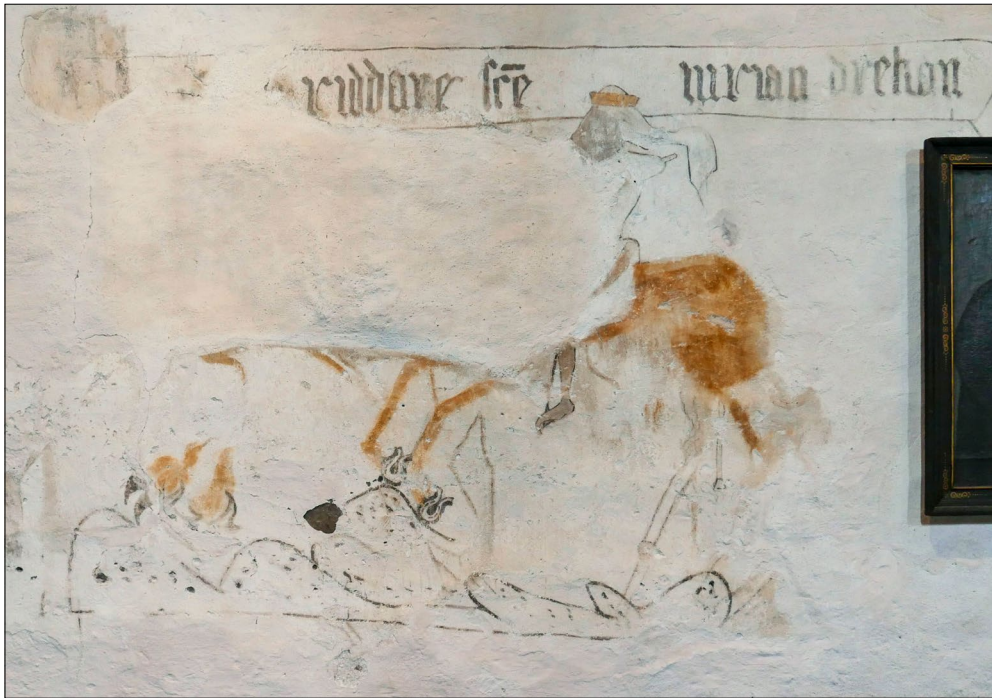
12. Tingvoll Church. St George and the dragon on the south wall in the nave  
(Photo: Susanne Kaun, 2018)

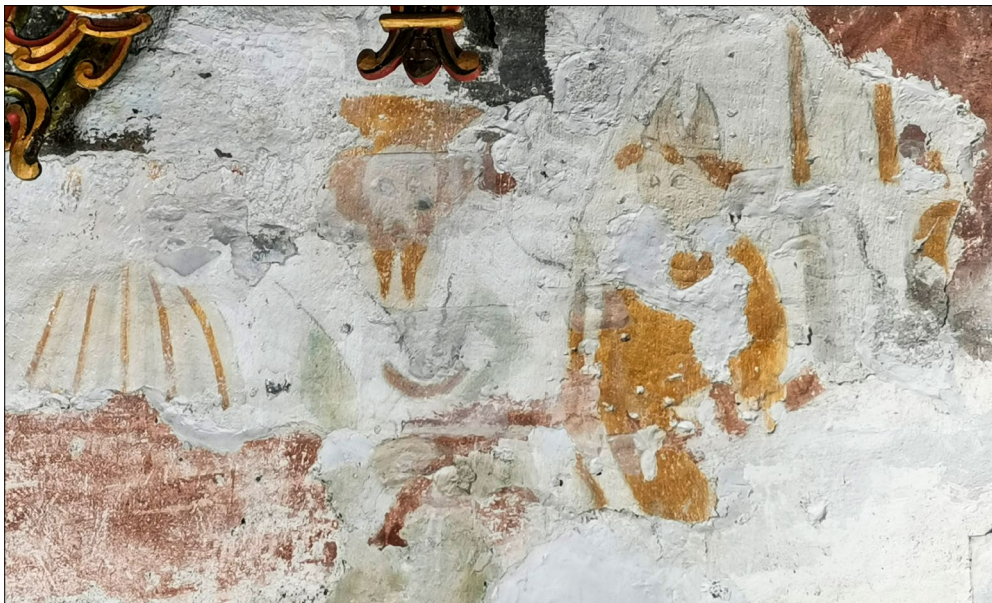
13. Tingvoll Church. Partly uncovered wall paintings, depicting a prominent man and a bishop  
on the north wall in the nave (Photo: Susanne Kaun, 2022)

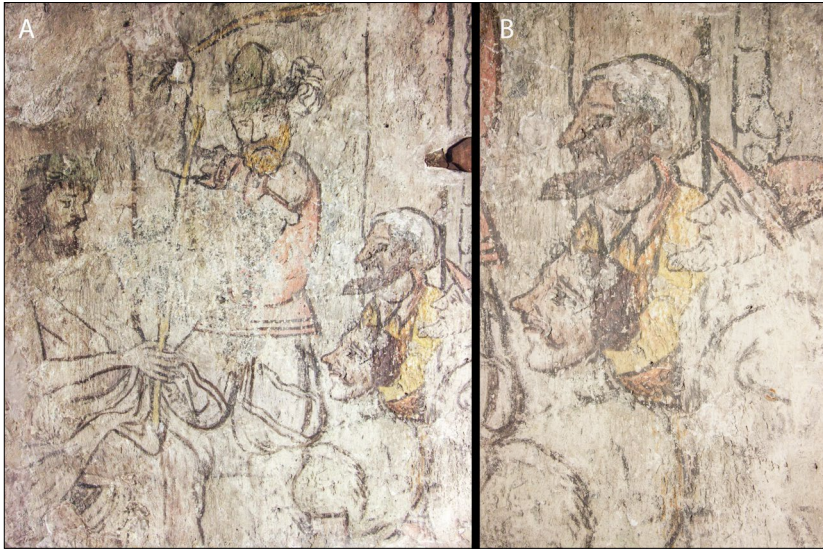
14. *St Mary's Church in Bergen. (A) The Flagellation and (B) a detail. Today this mural is covered by the pulpit (Photos: Susanne Kaun, 2010)*

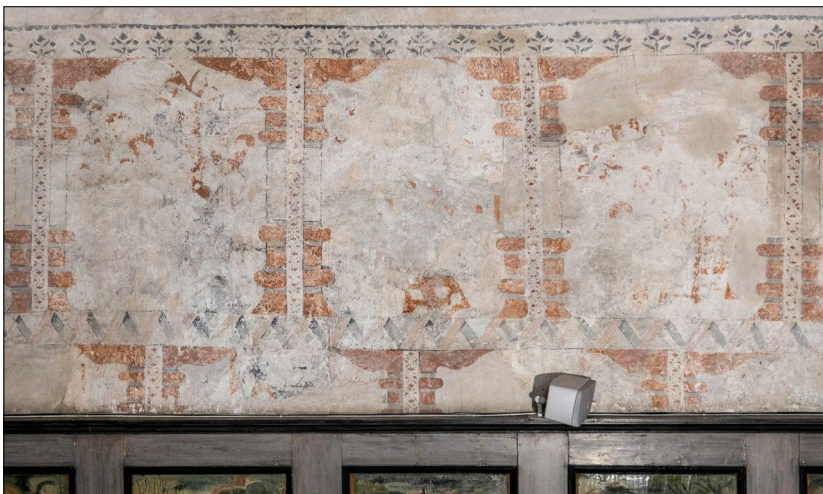
15. *Stiklestad Church. Part of a frieze with fragmentary figurative scenes surrounded by reconstructed painted frames on the north wall of the nave (Photo: Susanne Kaun, 2020)*

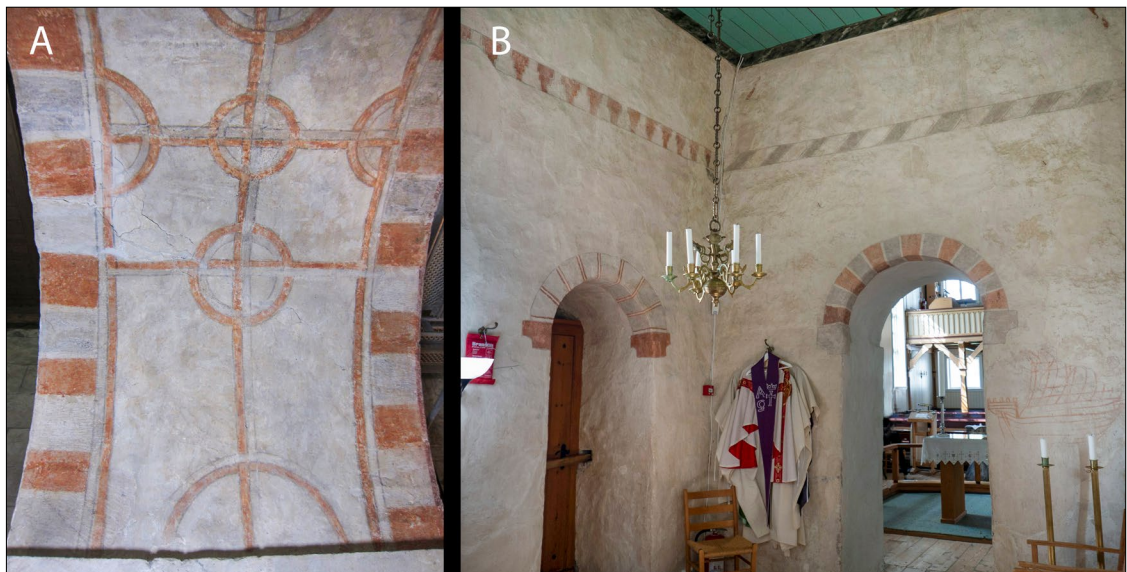
16. Murals with architectural ornament. (A) Chancel arch in Nes Church, Telemark. (B) Chancel walls in Siljan Church (Photos: Susanne Kaun, 2020)

Typical architectural ornamental painting includes ashlar stone imitations and dogtooth- and zig-zag borders placed in and/or around window openings, altar niches, and chancel arches, as well as running along the walls or ceilings (Fig. 16). Borders are frequently shaped as hearts, lilies (*fleur de lis*) and clover.

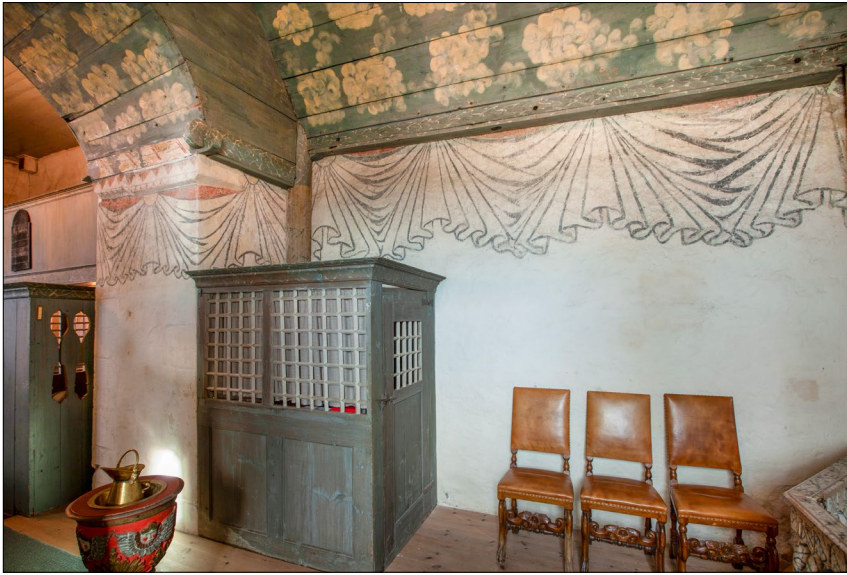
17. Romnes Church.  
 Drapery painting in the  
 chancel (Photo: Susanne  
 Kaun, 2021)

Three churches have examples of painted drapery, all in the chancel and all from the county of Telemark: the Romnes (Fig. 17), Seljord and Nes churches. In Seljord (1150–1250), drapery has been preserved behind the altar in the apse, below the traces of figures. It falls from the middle of the wall and vanishes 1.5 metres above the floor. In Nes, it runs along the lower part of the murals on the chancel walls and also from the middle of the wall, but ends one to two metres from the floor. The drapery is connected to a frieze of medallions with animal motifs, which evokes the pictorial structure of the textile *refil*.<sup>47</sup> In Romnes Church (1150–1250), on the other hand, the drapery is not connected to any figurative motifs, but starts at the upper edges (i.e. not in the centre) of the north and south walls at the back of the apse and ends about two metres above the floor. These draperies imitate textiles commonly used to cover medieval church walls, either for practical insulation reasons or for aesthetic, decorative purposes.<sup>48</sup>

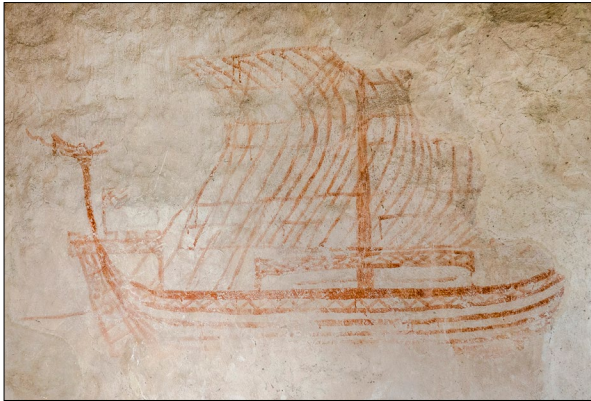
18. *Siljan Church (1150–1250). A single image of a medieval ship in the chancel (Photo: Susanne Kaun, 2020)*

Ship images are widespread and are found in churches and other types of building all over Europe, and also from several different periods.<sup>52</sup> These are frequently difficult to date. In Norway, many of them depict typical medieval ship types, as in the Kviteseid and Siljan churches (Fig. 18). Given that ship images are widely found, they must have had a known symbolic meaning, for example representing salvation or a votive function.<sup>53</sup>
