# ART FOR COMMUNITY

# CONDITION AND RISK ASSESSMENT OF SOCIALIST-ERA MOSAICS IN SLOVENIA

**Blaž Šeme**

University of  
Ljubljana,  
Academy of Fine  
Arts and Design

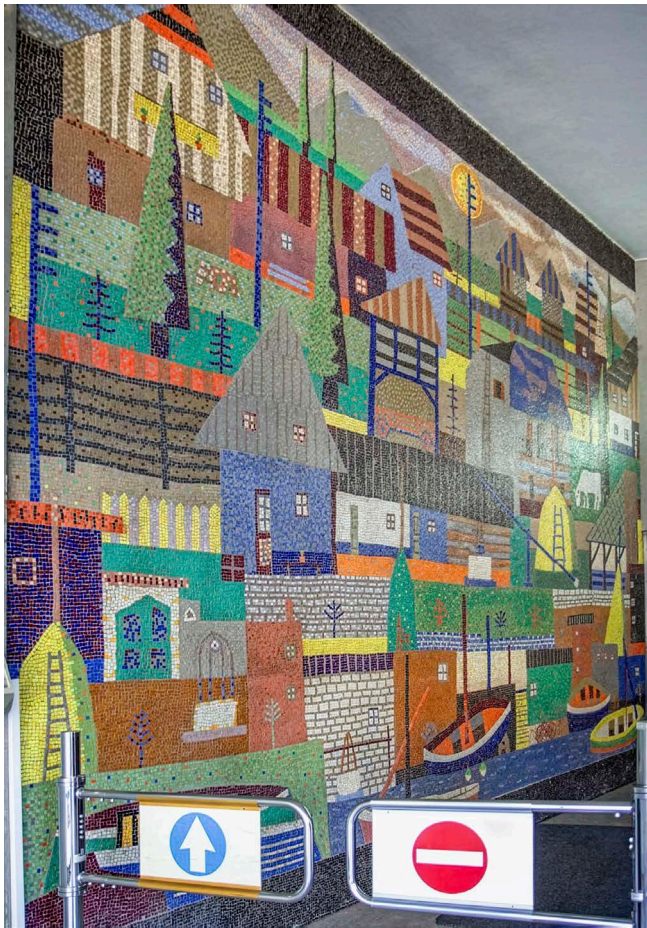
*Figure 3. Lojze Spacal, Alegorija podeželja (Allegory of the Countryside), mosaic, 1955, building of the former Main Cooperative Union (Glavna zadružna zveza), now the District State Prosecutor's Office, Ljubljana. The view is partially obstructed by security equipment at the entrance. Photo: Blaž Šeme, 2020.*

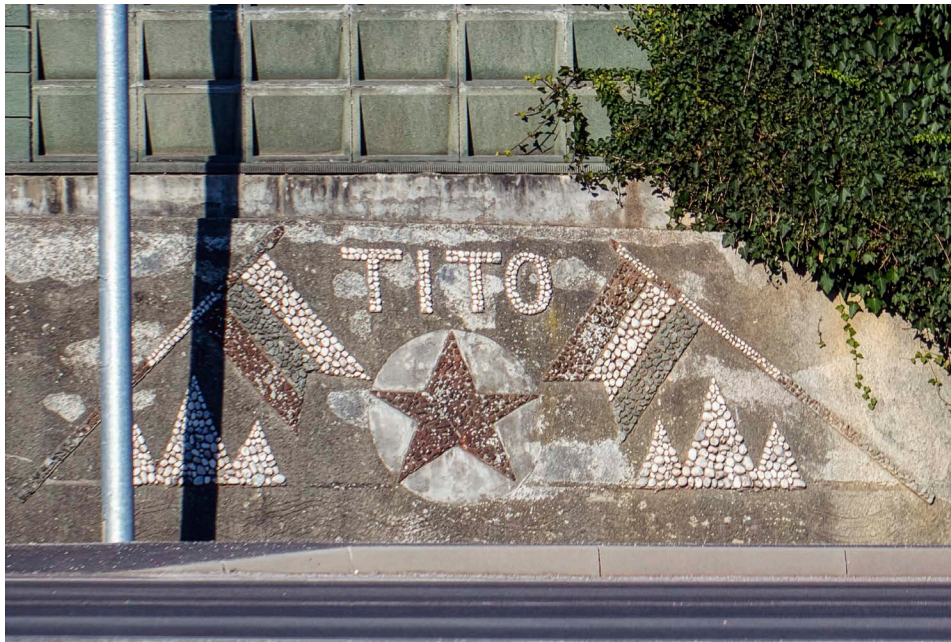
*Figure 5. Unknown artist, Mozaik slovensko-hrvaškega prijateljstva (Mosaic of Slovenian–Croatian Friendship), also known as Mozaik Tito (Tito Mosaic), mosaic, date unknown, Log pri Brezovici. The mosaic was restored in 2010; in recent years, it has been partially obscured by a lamppost. Photo: Blaž Šeme, 2023.*

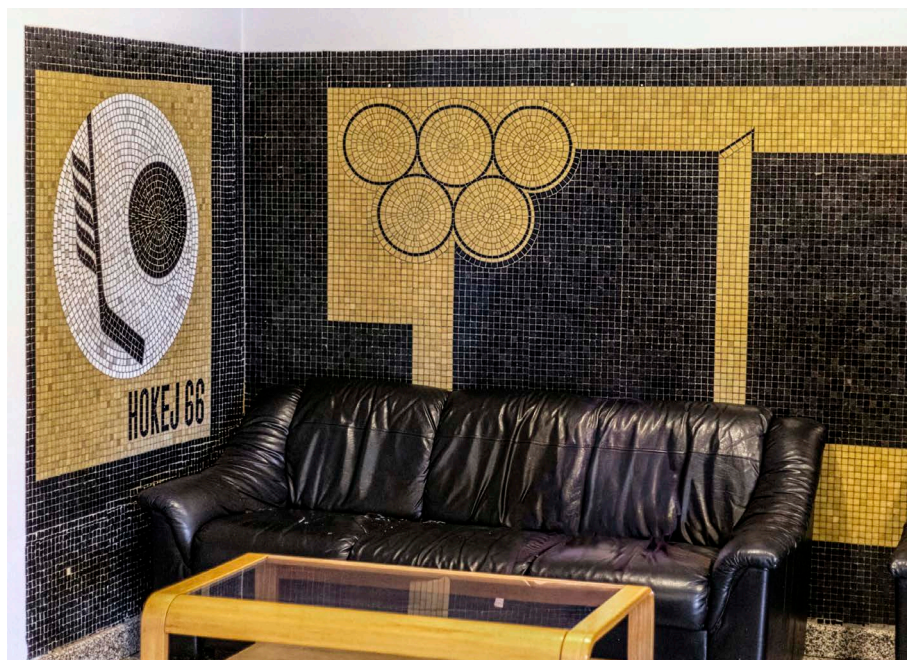
Figure 7. Unknown artist, mosaic, ca. 1964, Tivoli Hall, Ljubljana. The photograph shows the left half of the mosaic in the entrance lobby, including the sign for the 1966 Ice Hockey World Championship. Photo: Blaž Šeme, 2025.

Most of the mosaics are on the walls of buildings, with only two examples of floor mosaics in Bled and Nova Gorica. At least forty-nine buildings are public: the parliament, municipal buildings, other state institutions, state protocol buildings, buildings of public companies, cultural centres, schools, and so on. A recently listed mosaic by an unknown artist (the “HOKEJ 66” sign is based on a design by the Bosnian artist Dževad Hozo) is located in the Hala Tivoli sports complex in Ljubljana<sup>19</sup> [Figure 7]. Only

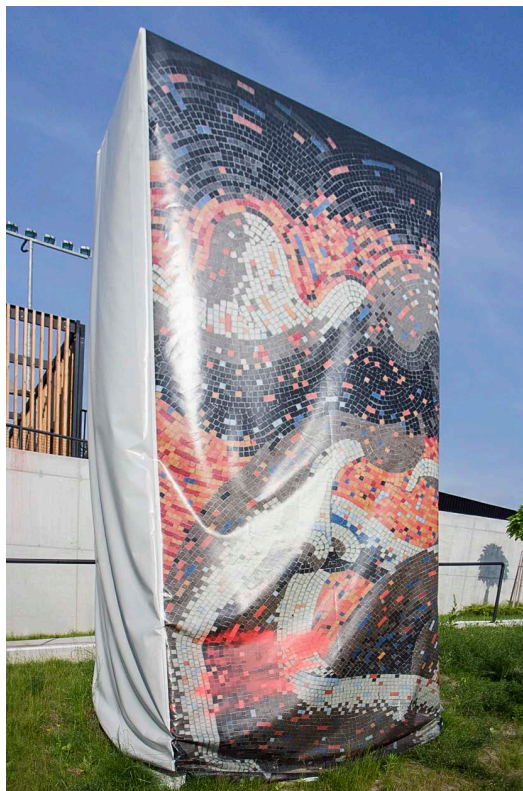
*Figure 8. Karel Pečko, mosaic formerly installed in the Bellevue restaurant, Legen, date unknown. Removed from the wall and covered with a protective sheet, it awaits reinstallation near the swimming pool complex in Slovenj Gradec.  
Photo: Blaž Šeme, 2023.*

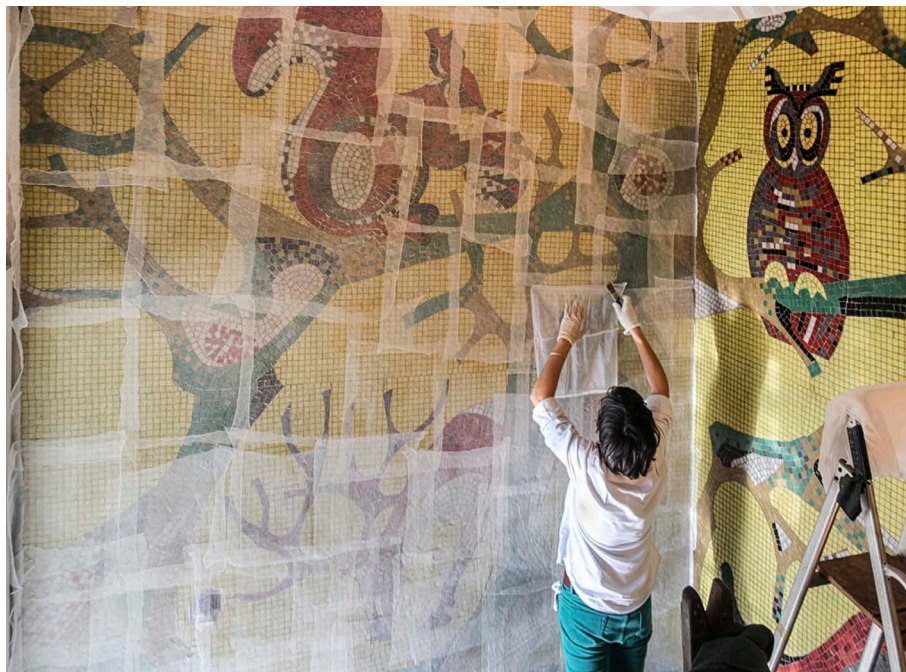
Figure 9. Unknown artist, mosaic, ca. 1962, Ljubljana City Savings Bank, Ljubljana. Protection of the mosaic surface before detachment during the 2018 conservation-restoration treatment. Photo: Blaž Šeme, 2018.

The mosaic at the Ljubljana City Savings Bank is rated as 2 (severely damaged) because, despite the recent successful relocation and presentation

of part of the mosaic, much of the remaining mosaic is either destroyed or awaiting further conservation-restoration in the studio of UL ALUO. The condition of the largely destroyed mosaics at the Petrol station on Trieste Street (*Tržaška cesta*) in Ljubljana and of Pečko's mosaic in the Bank in Slovenj Gradec was rated as 1 (destroyed). Otherwise, in the risk assessment, eleven mosaics are assessed as being at higher risk, mainly because they are exposed outdoors, two of them are indoors but in a location where they are likely to be physically damaged, and two are floor mosaics subject to permanent foot traffic. Some of the mosaics have presentation problems because they are partly covered or less visible due to furniture, storage of various objects, changes in use, alterations, and so on. The analysis shows that, among the mosaics created in the 1950s, there is a higher proportion of very well-preserved mosaics (rated 5) than among those from other decades, but at the same time there is also a slightly higher proportion of poorly preserved mosaics (rated 2) [Figure 14].

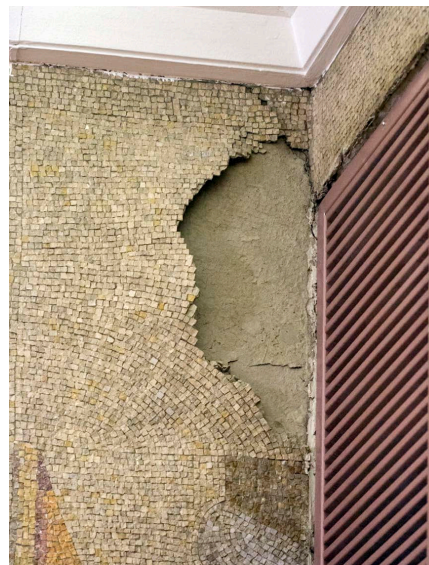
Of the sixty-four mosaics in the inventory, a more detailed risk assessment analysis was carried out for fifty-five because data of sufficient quality are not available for the others. On a scale of 1 to 5, thirty-three mosaics were assessed as 5 (very well preserved) [Figure 10], fifteen as 4 (fairly well preserved), and three as 3 (less well preserved) and in need of conservation-restoration mainly due to mosaic pieces falling off. The last group includes Seljak Čopič's mosaics on the monument in Mislinja [Figure 11] and in the Zagorje ob Savi Cultural Centre, and Bernard's mosaic at Petrol's headquarters in Ljubljana [Figure 12]. An intervention on Seljak's mosaic in Zagorje ob Savi is urgently needed because part of the mosaic around the air vent has already fallen off [Figure 13].

Figure 13. Ivan Seljak Čopič, *Protest rudarjev* (Miners' Protest), mosaic, 1961, Cultural Centre, Zagorje ob Savi. Detail. The mosaic is particularly at risk around the air vent, where part of it has already detached. Photo: Blaž Šeme, 2023.
